Accessible Route AUDIT (Version 1.0)

Denis Anson, MS, OTR & Kathy Longenecker Rust

Last updated January 26, 2009

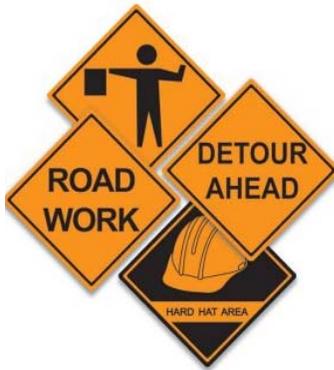
[Figure 1: Detour Signs](#)

Construction or temporary obstacles (e.g. reserved parking for special events) frequently present major problems for individuals with disabilities. For example, yellow tape placed more than 27 inches off the ground will not protect an individual who walks with a cane, and at any height are less detectable than a solid barrier. Dual height barriers at 27” and 9” are much more usable. This AUDIT may be extremely helpful when planning in these instances.

Brief Description: Figure 1: Detour sign. Four diamond road signs, colored in orange in black, indicating there is construction road work taking place and cautioning those in the area.

Essential Description: The orange road signs are expressing the concept that before preceding any further, an individual must take caution. They indicate that there is some type of work being done that will impact the pathway of travel.

Detailed Description: An orange diamond is situated in the upper right corner with a thin black border around the outside. Within the orange diamond is a bolded person, in the color black, with their right arm bent at the elbow up in the air and their left arm holding a thick black flag in the shape of a square. In the bottom left hand corner of the diamond with the person there appears an additional orange diamond that is overlapping. The orange diamond also has a thin black border around the outside. Inside the diamond are the words bolded and in black stating "ROAD WORK." In the bottom right hand corner of the orange ROAD WORK diamond there is an additional diamond that is not touching. The diamond is filled in with black and has a thin orange border around the outside. Within the diamond top and center is a hard hat which is colored orange. Below the hard hat are words colored in black within an orange background stating "HARD HAT AREA." In the upper right hand corner of the black diamond with the orange hard hat, there appears another orange diamond overlapping the top part of the hard hat. The orange diamond has a thin black border and in the inside are the words bolded, and centered stating "DETOUR AHEAD."
